**Flood Control Project Maintenance
Levee Inspections**

Maintenance Issue Types Only, Levee Inspection Report By Mile - Fall 2014

Eastern Honcut Creek

Waterway	Bank	Unit Miles	Inspection Start/End	Inspector
Unit No. 01 Van Tress	Left	1.46	10/14/2014 10/14/2014	Matthew Hoffman

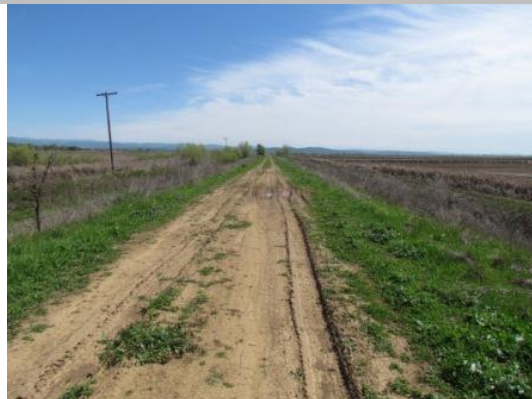
Photo 1 of 2 : FA_2014_NA0006_252_1_20141013_00001.jpg

This photo was taken from the levee crown facing east looking at typical vegetation on both the landward and waterward levee slopes. Spring 2014.

LM Start	0.01	Rating **	U	Issue No.	1
LM End	1.50	Issue Type +	Ma	Location *	LS
Category	Earthen Levee			GPS Latitude/Longitude	
				Start	End
Item	Vegetation			39.298521 °	39.295267 °
				-121.569497 °	-121.546559 °
DWR ID	DWR_NA0006_01_s_2012_1				
Action/Comments					
Remove the wild growth other than native grasses from the levee slopes.

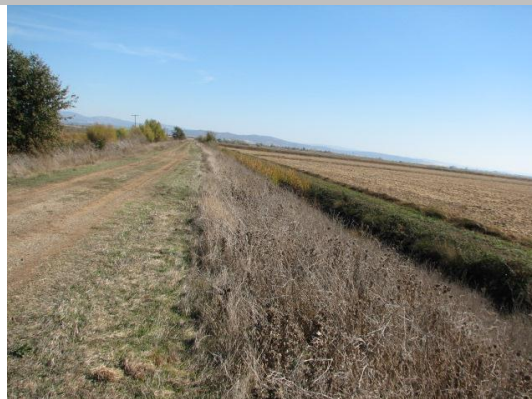
Photo 2 of 2 : FA_2014_NA0006_252_1_20141013_00002.jpg

This photo shows the landside of the levee at levee mile 0.10.

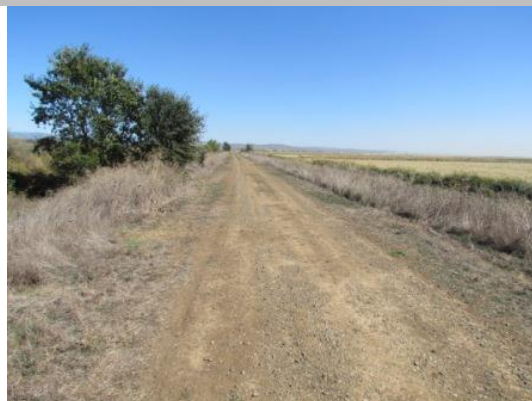
Photo 1 of 1 : FA_2014_NA0006_252_3_20141013_00003.jpg

This photo was taken from the levee crown facing east looking at the vegetation on both the landward and waterward levee slopes.

LM Start	0.05	Rating **	U	Issue No.	3
LM End	1.50	Issue Type +	Ma	Location *	WS
Category	Earthen Levee			GPS Latitude/Longitude	
				Start	End
Item	Vegetation			39.298849 °	39.295267 °
				-121.569419 °	-121.546560 °
DWR ID	DWR_NA0006_01_s_2012_3				
Action/Comments					
Remove the wild growth other than native grasses from the levee slopes.

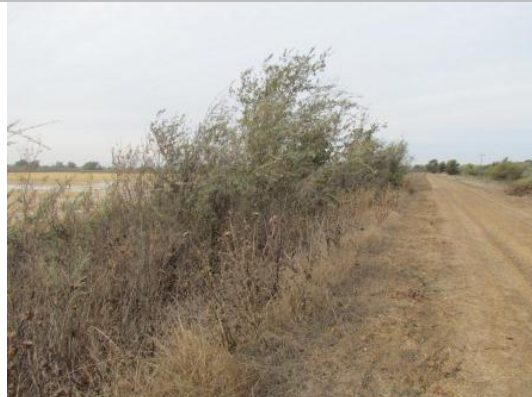
Photo 1 of 1 : FA_2014_NA0006_252_16_20141017_00012.jpg

LM Start	0.24	Rating **	U	Issue No.	16
LM End	0.24	Issue Type +	Ma	Location *	LS
Category	Earthen Levee			GPS Latitude/Longitude	
				Start	End
Item	Trim / Thin Trees			39.298786 °	39.298786 °
				-121.566159 °	-121.566159 °
DWR ID	DWR_NA0006_01_f_2014_16				
Action/Comments					
Thin trees to allow visibility of the ground and room to flood fight. Inspector Comments: Trees should be trimmed up or removed to maintain visibility of landward levee slope.

This photo was taken from the crown facing west looking down the landward levee slope at trees that either need to be trimmed up or removed to provide slope visibility. Fall 2014.

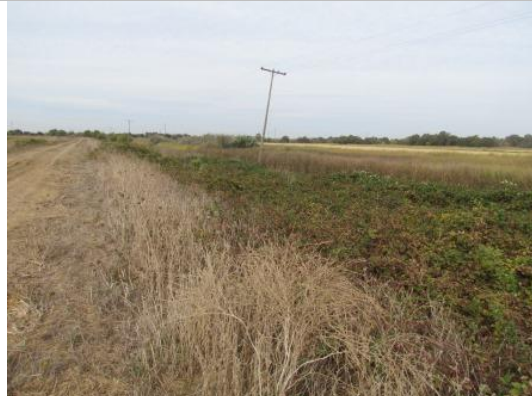
Photo 1 of 1 : FA_2014_NA0006_252_15_20141017_00011.jpg

LM Start	0.46	Rating **	U	Issue No.	15
LM End	0.46	Issue Type +	Ma	Location *	WS
Category	Earthen Levee			GPS Latitude/Longitude	
				Start	End
Item	Vegetation			39.298283 °	39.298283 °
				-121.562021 °	-121.562021 °
DWR ID	DWR_NA0006_01_f_2014_15				
Action/Comments					
Remove the wild growth other than native grasses from the levee slopes.					
Inspector Comments: Berry bushes on waterward levee slope need to be trimmed back.

This photo was taken from the crown facing west looking down the waterward levee slope at berry bushes needing removal. Fall 2014.
